Lewis Wind Power EIS a critical review

**Lewis Wind Power (LWP) Environmental Impact
Statements (EIS) 2004 and 2006 - A Critical
Review**

R A Lindsay and J Freeman

March 2008

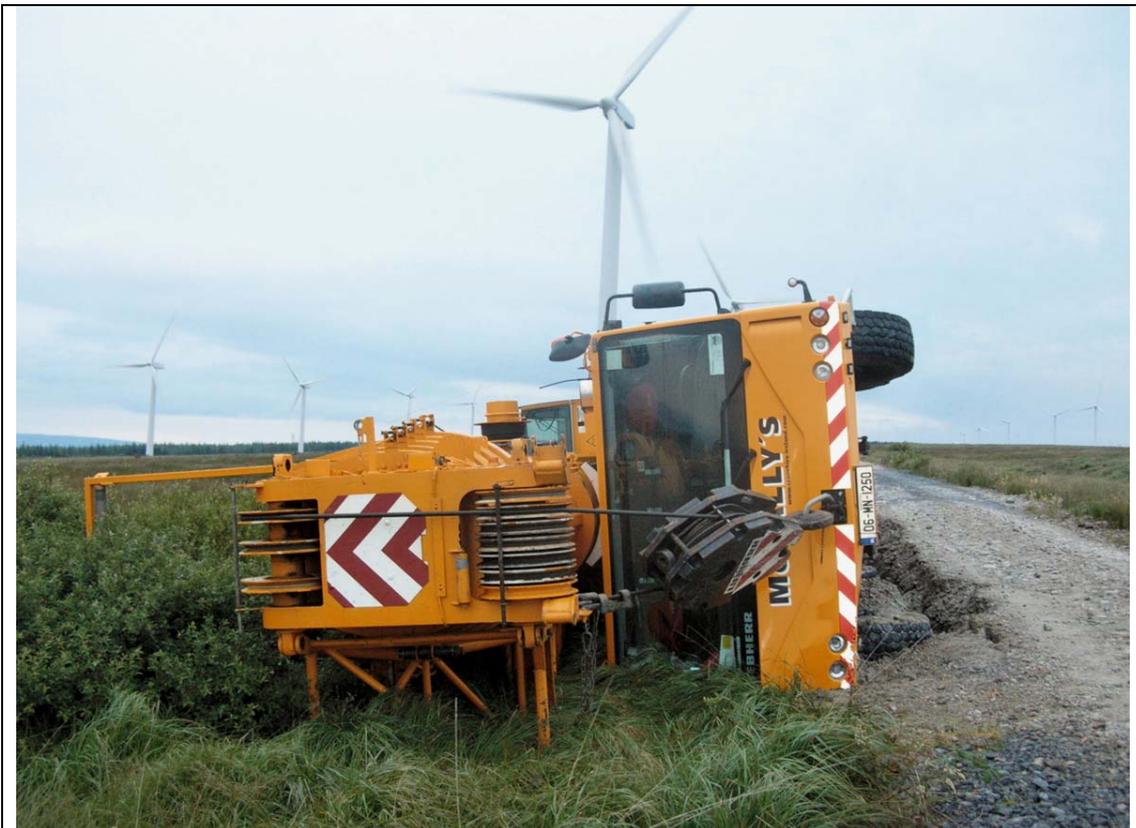
Figure 4. Crane accident arising from failure of floating road.

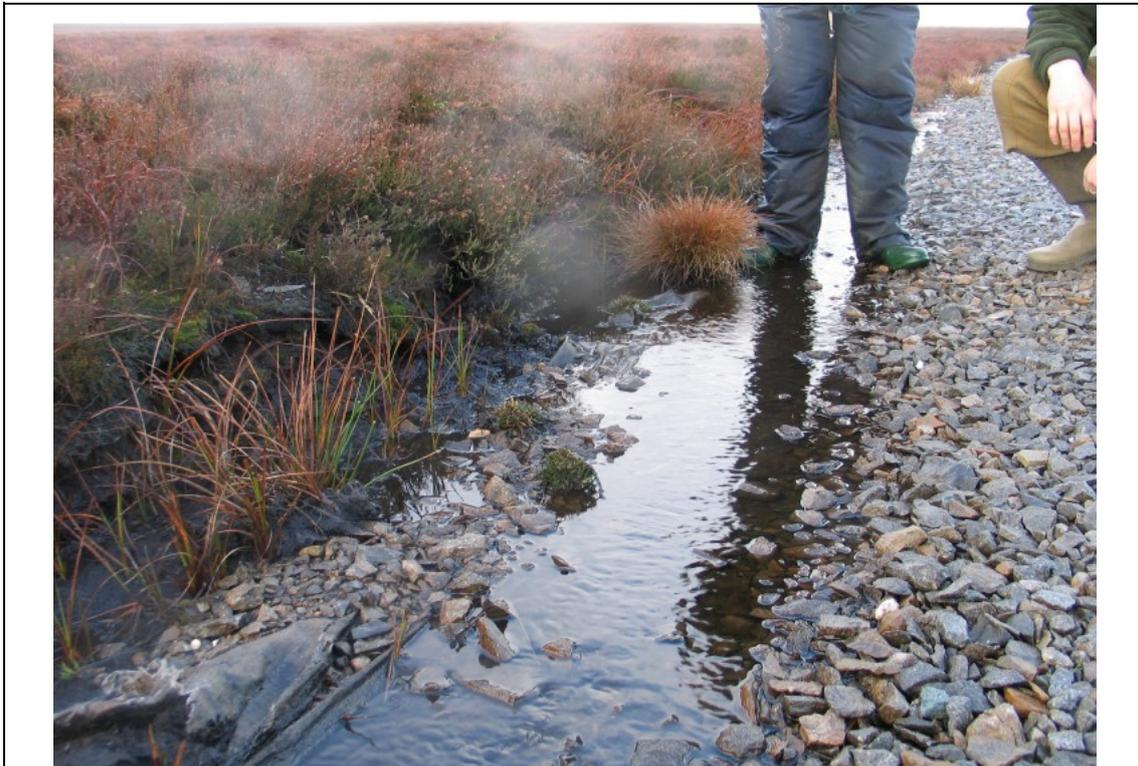
Figure 6. Ponding alongside a floating road.

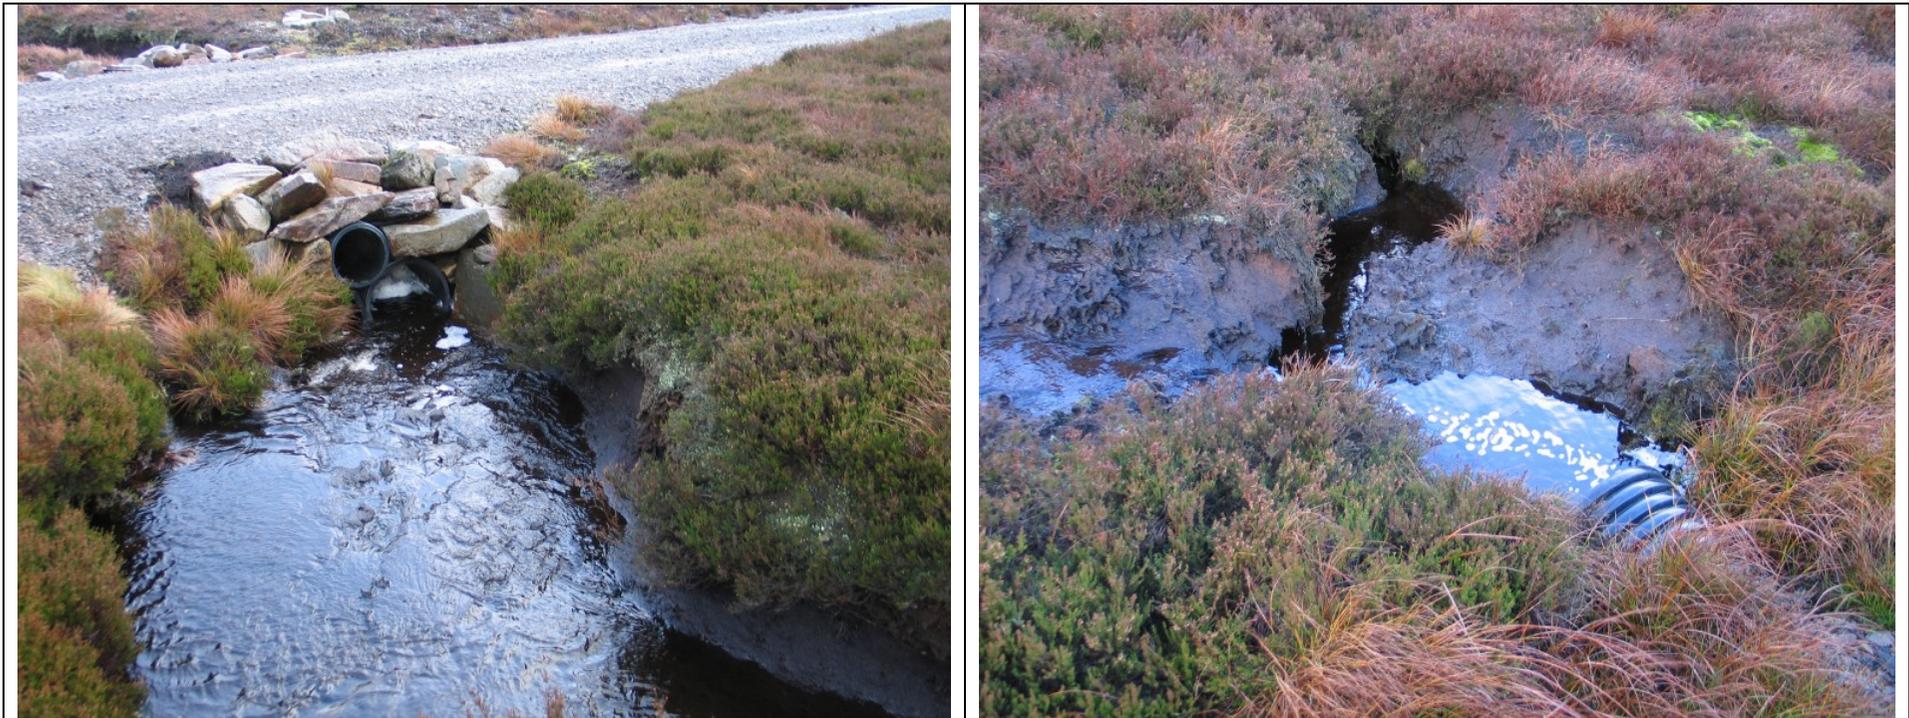
Figure 7. Cross-drains associated with a floating road.

It might be argued that LWP 2004 EIS, Vol.4, Chapter 7, Fig. 7.9 shows a soakaway “reinforced with geogrid or stone” and thus the erosive power of the water will be dissipated, but the problem lies not merely with the force of the outflow water; in mineral ground perhaps the dissipated water would indeed soak away, but this is a peat soil, which is already saturated, and this extra water will not simply soak away. The entire volume will flow off the stone and into the nearest erosion gully downslope. It is this volume that is a problem in terms of both erosion and vegetation recovery. Examples of precisely such problems can be seen from Bowes Moor, northern England, in Figure 7.

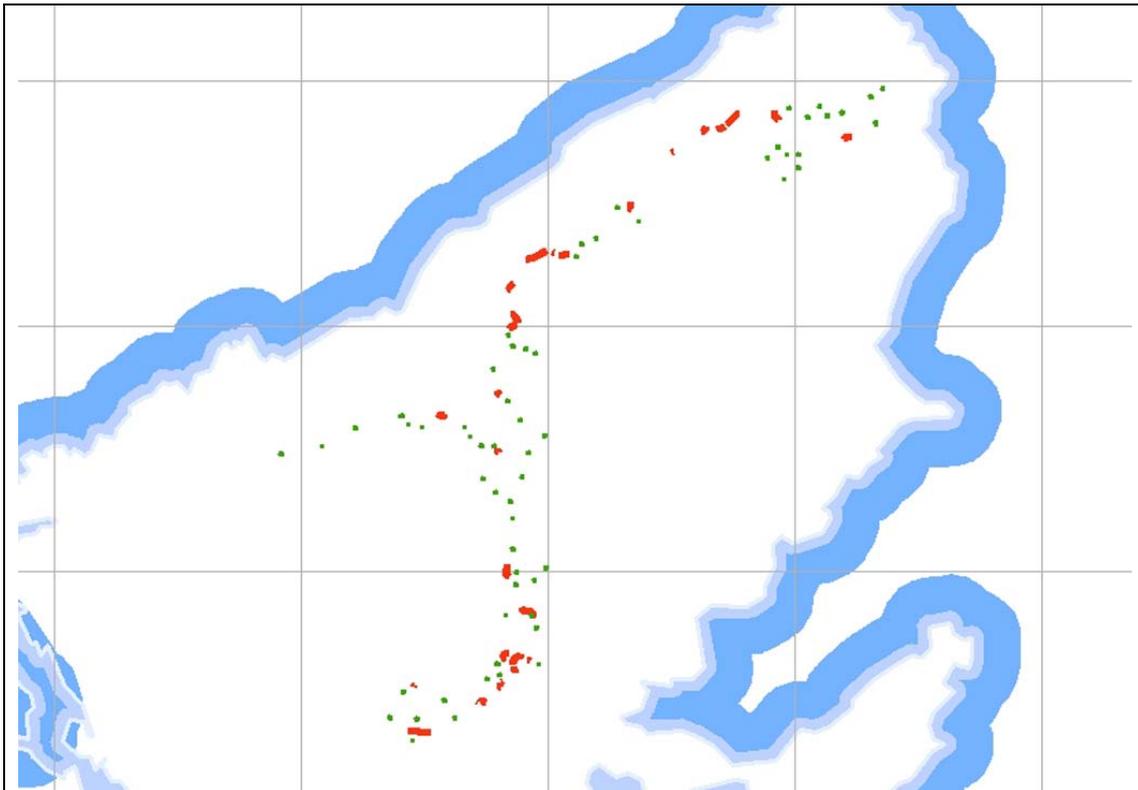
Figure 23. Locations for missing or unreadable LWP peat deths.
 Symbolised map of road sections where peat depths for the proposed LWP windfarm road-line and turbine bases are either missing or impossible to read from [LWP 2004 EIS, Vol.4, Chapter 10, Figs.10.3a-d](#). Red = missing data; Green = locations where the LWP data cannot be distinguished because the symbols on [LWP 2004 EIS, Vol.4, Chapter 10, Figs.10.3a-d](#) are obscured. The coastline is shown as concentric blue shading. The OS National Grid is displayed in grey as 10 km squares.

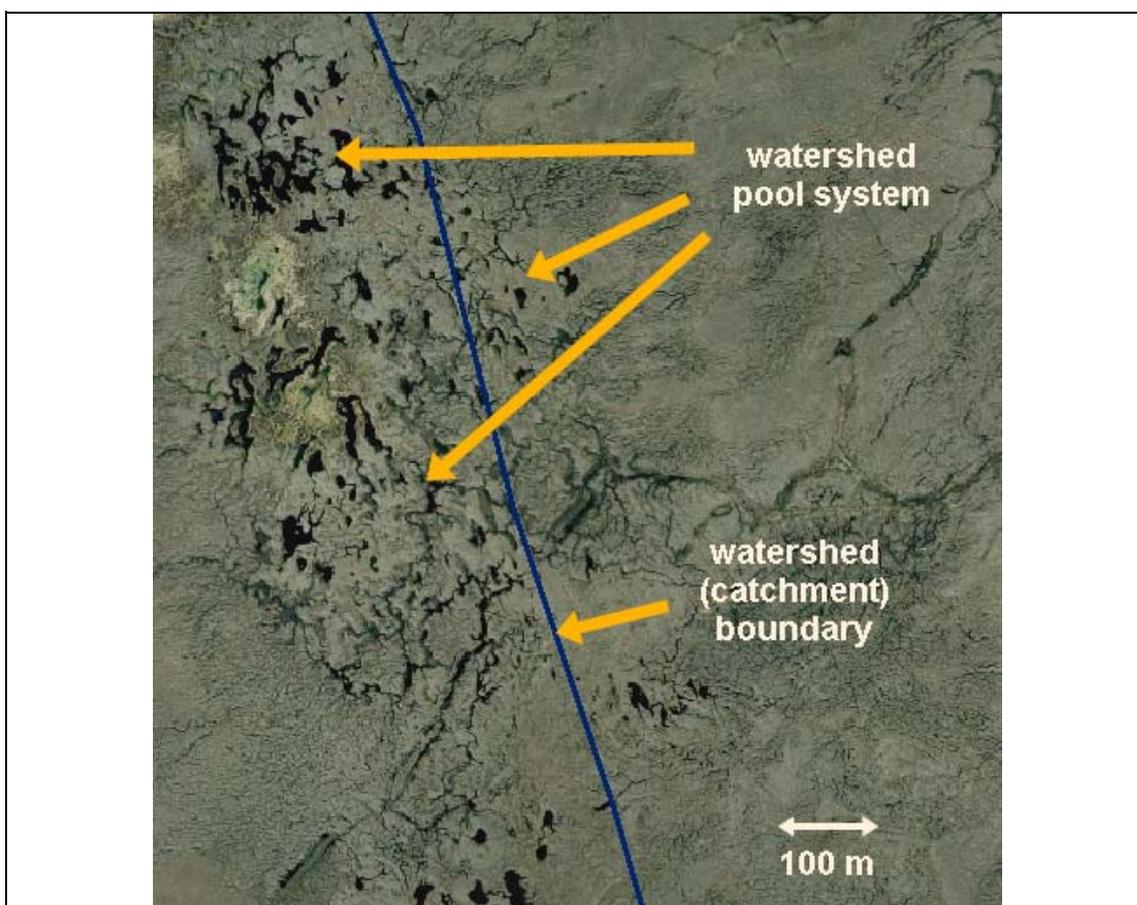
Figure 26. Catchment line cutting through watershed mire system. Aerial photograph of watershed pool system at NB 441566, with catchment boundary (dark blue line) cutting through the bog pool system. The catchment line separates LWP Catchments 10 and 11.

'Catchment' is therefore a concept with limited value when describing a watershed blanket mire such as that shown in Figure 26. The mire unit functions as a distinct hydro-morphological entity almost *despite* the catchment line. Consequently a different approach to classification and description is most usefully invoked when describing peat bog systems, particularly when dealing with extensive peatlands such as blanket mire landscapes.

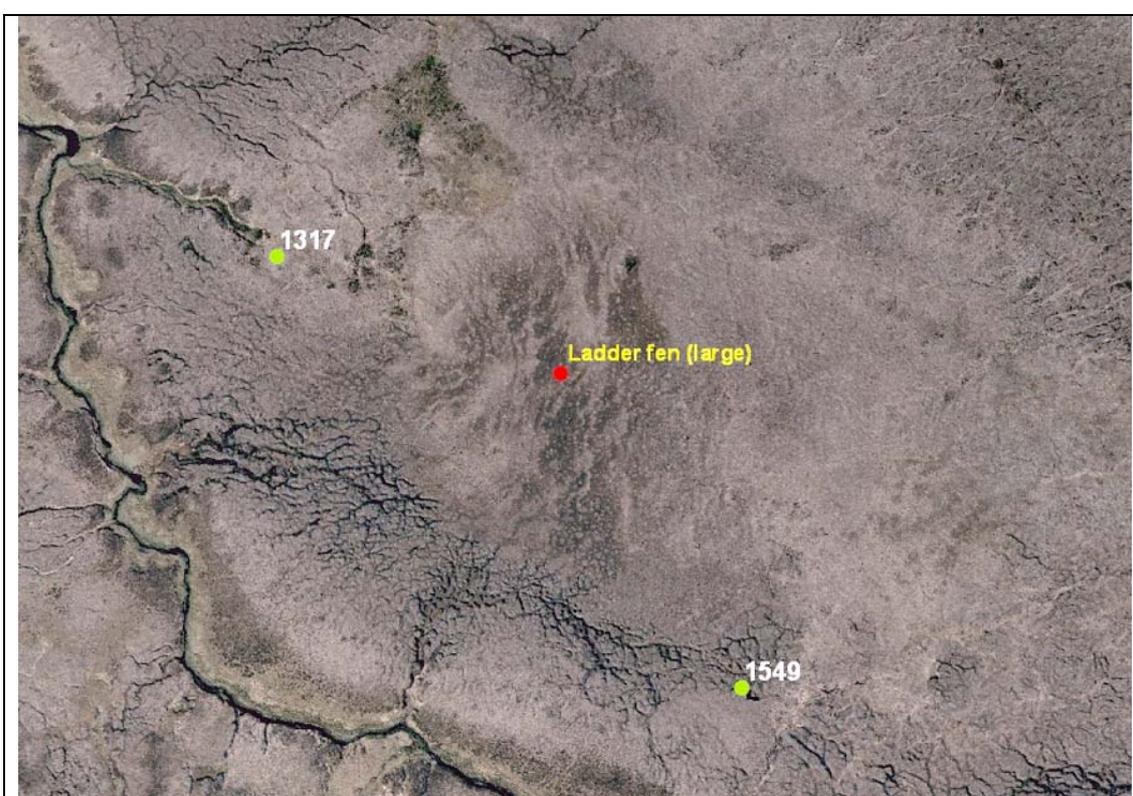
Figure 45. Mis-match between ladder fen and LWP Target Notes.

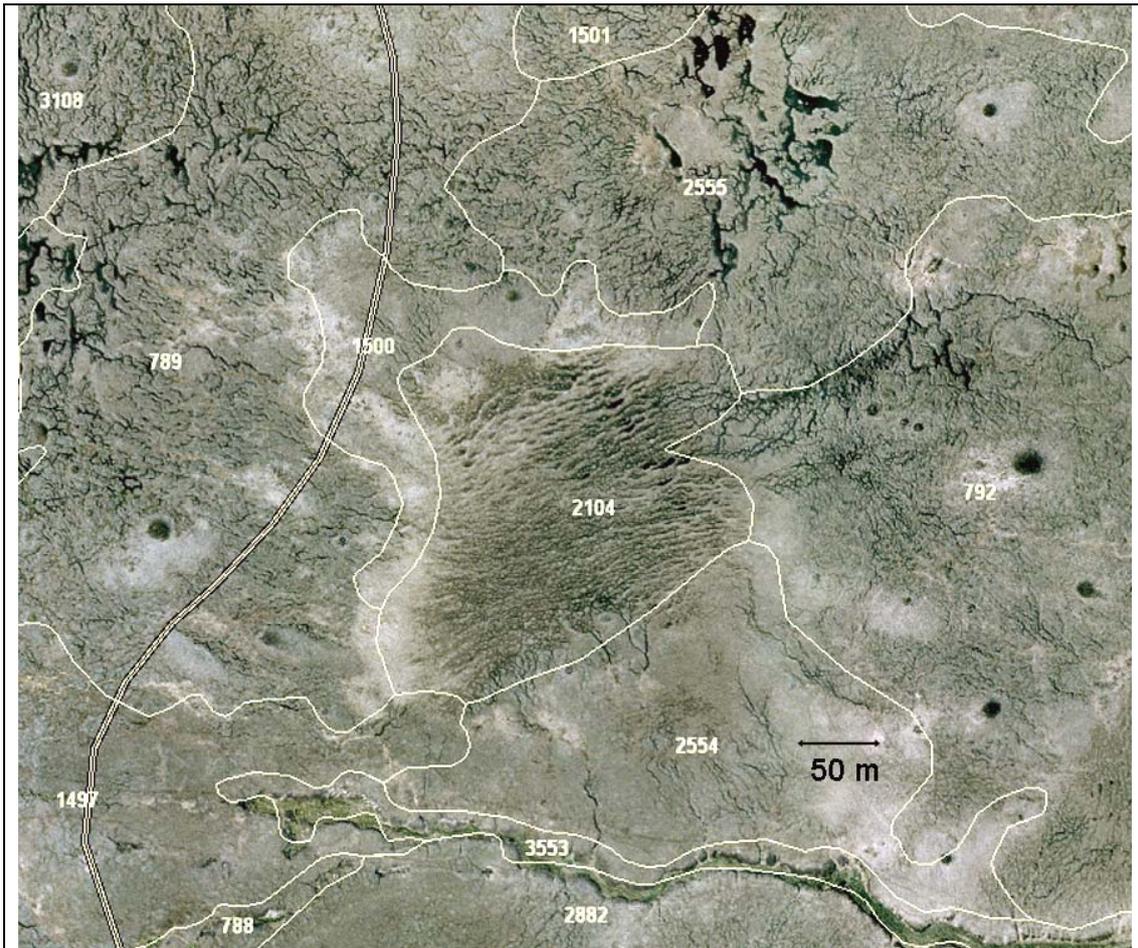
Figure 46. LWP HSA polygon boundary identifying ladder fen.

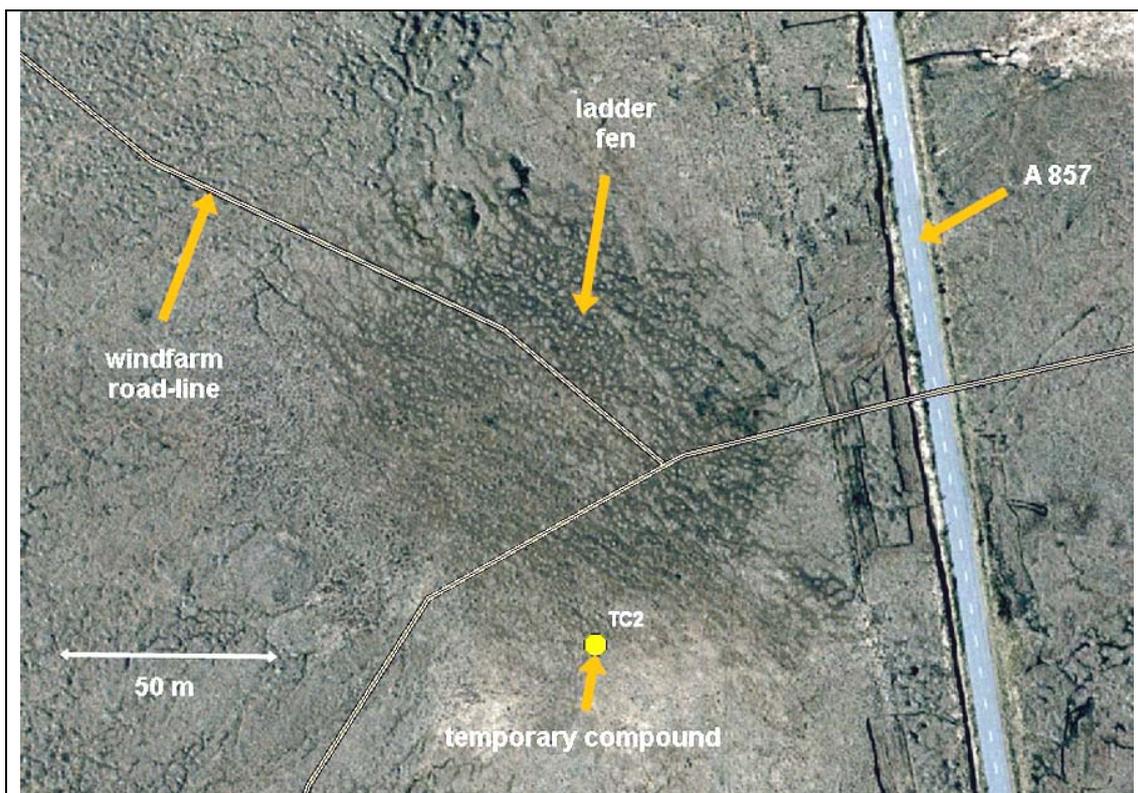
Figure 49. Ladder fen with proposed windfarm infrastructure.

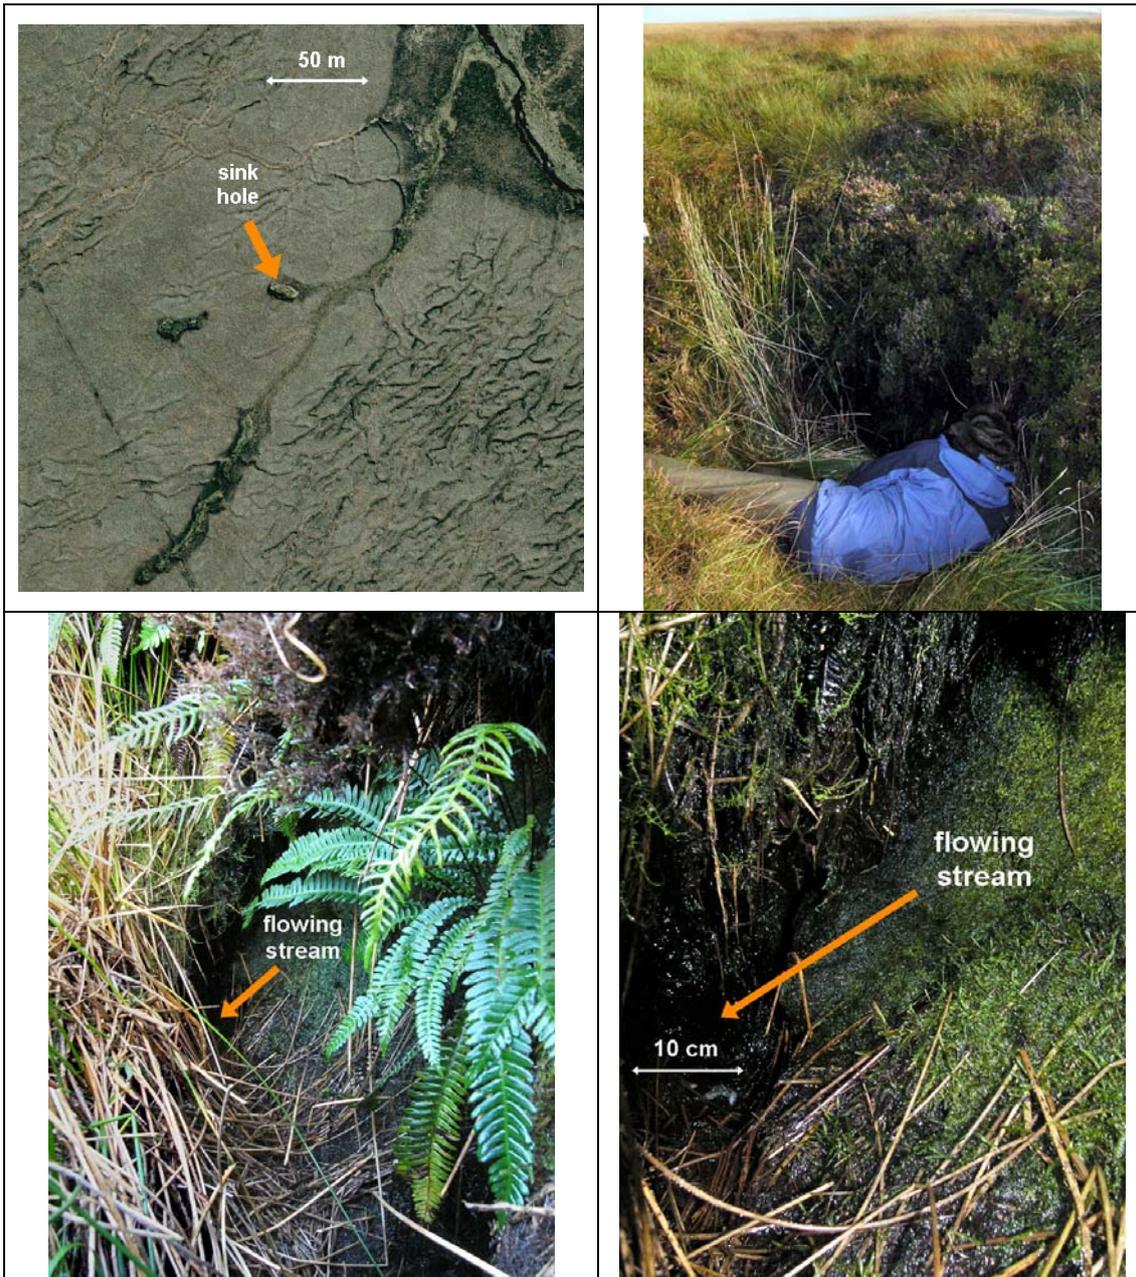
Figure 56. Detailed views of Lewis sink hole and peat pipe.

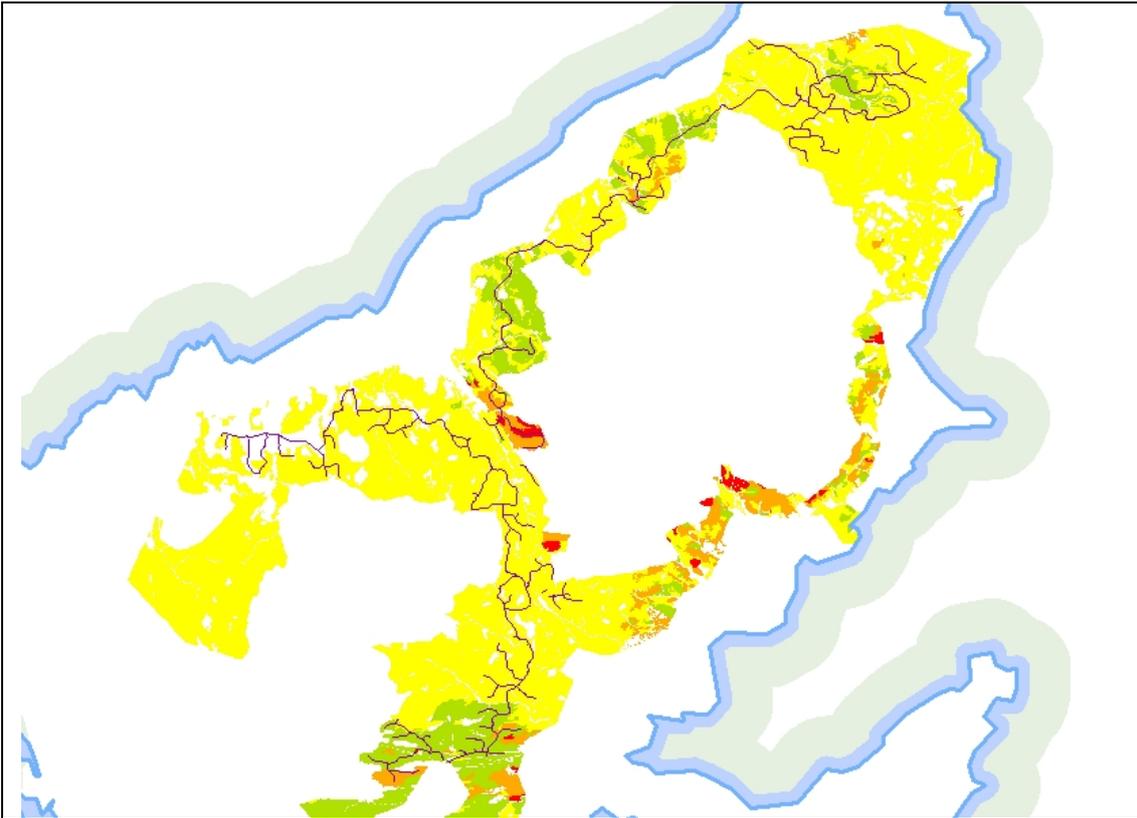
Figure 63. Distribution of burning impact according to the LWP HSA field data.
 Map of revised LWP windfarm road-line (dark line) displayed over categories of 'blanket bog burning impact' from the LWP HSA survey programme. Yellow = no impacts; Green = light impacts; Orange = moderate impacts; Red = high impact. Areas not classified as blanket bog for this item in the dataset (e.g. lochs) have been left blank. Coastline is shown as pale blue concentric lines.

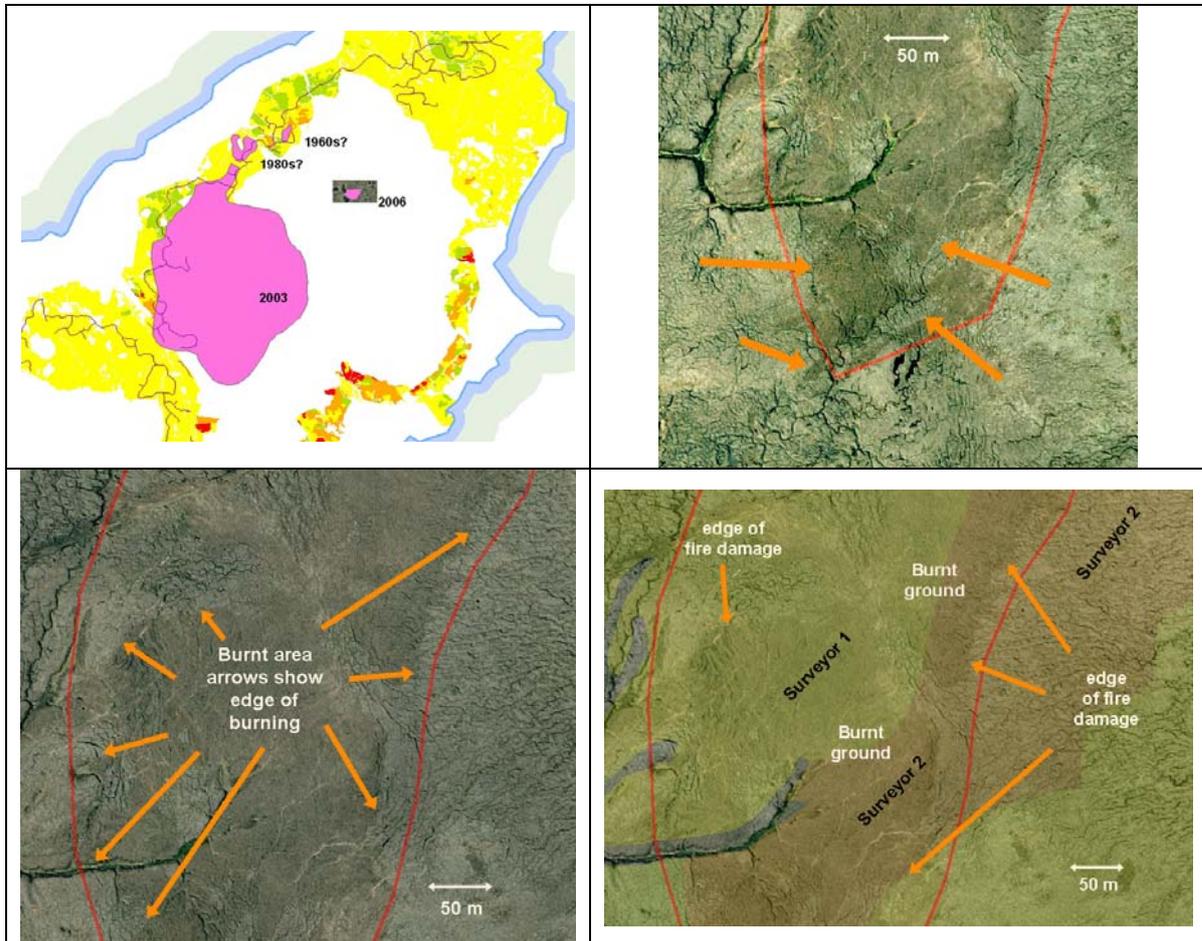
Figure 65. Relationship between LWP HSA recorded fire intensity and surveyor.

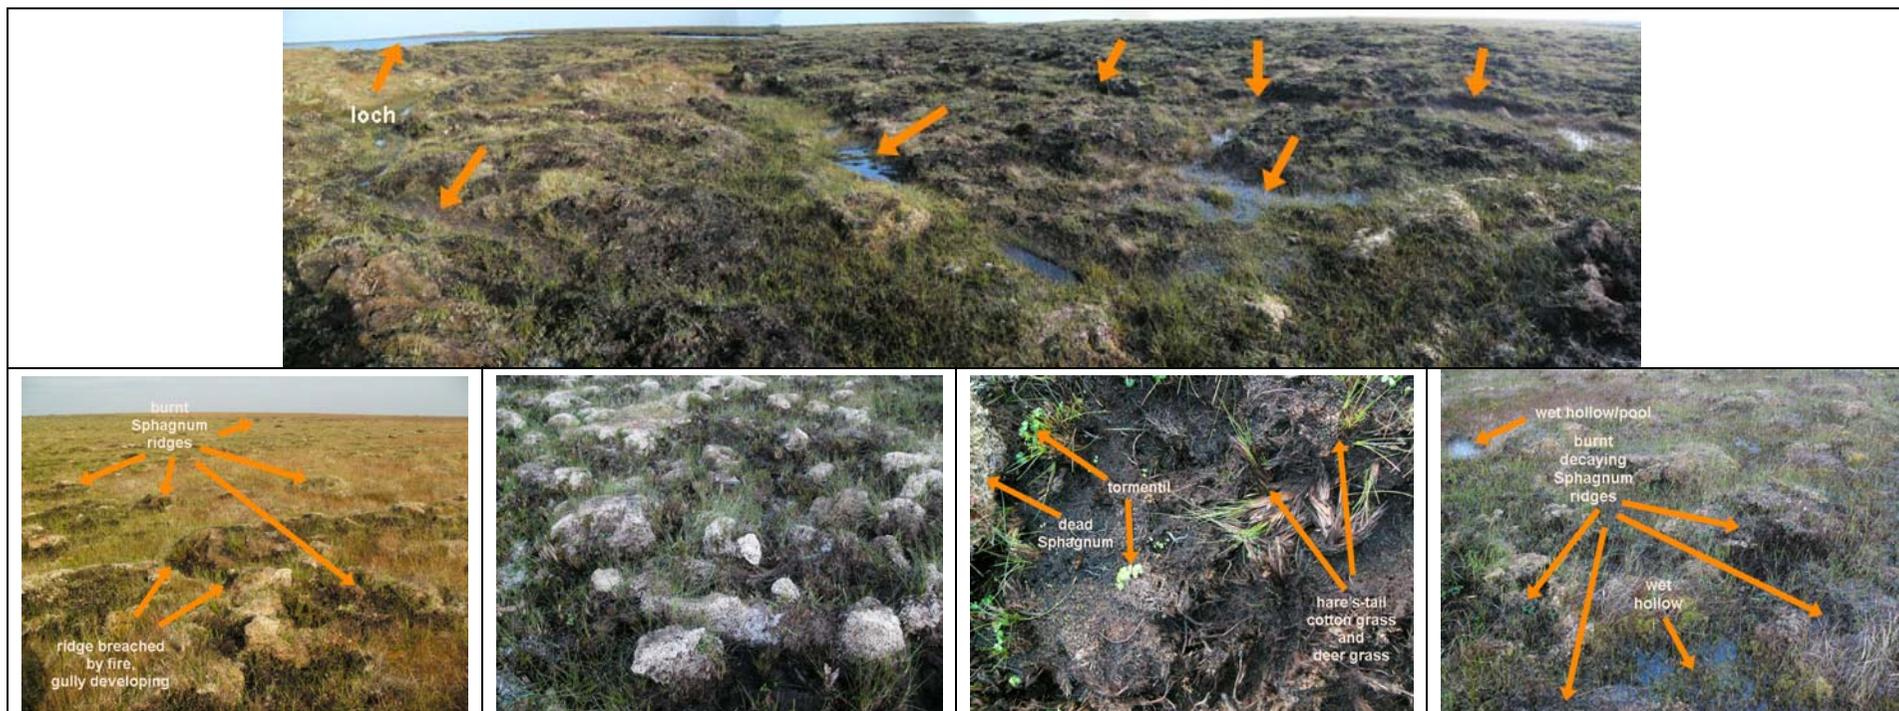
Figure 67. Ground conditions at UEL-recorded fire within the SAC.

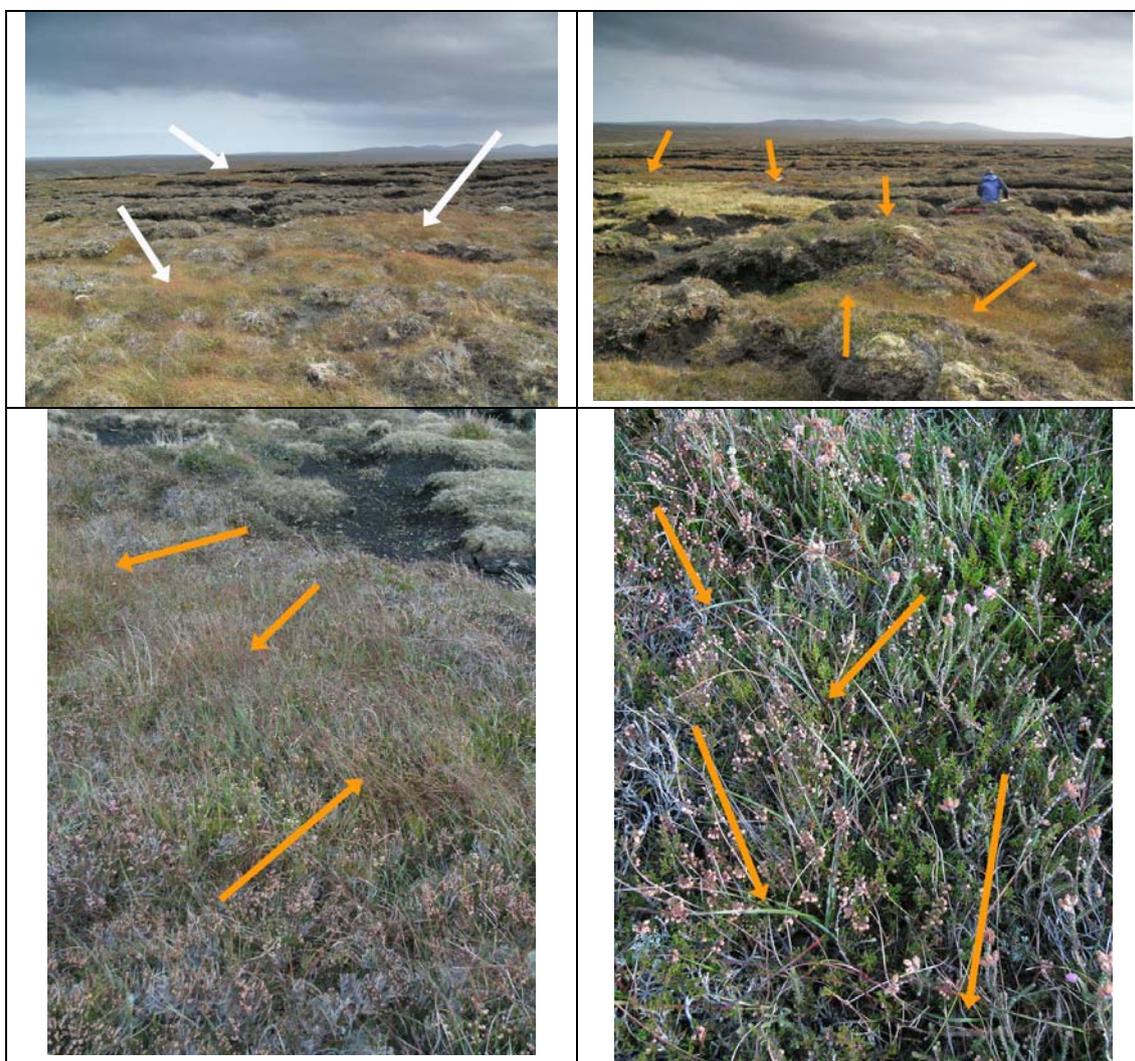
Figure 69. Ground conditions within an example of Erosion Class 8 and H10b 'dominance'.

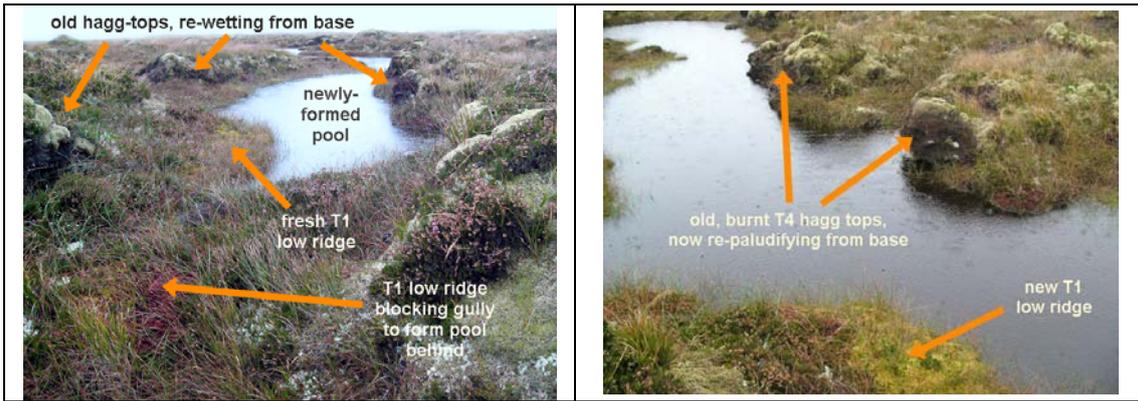
Figure 71. Examples of vegetation recovery and re-wetting within erosion systems. Examples of gully systems becoming re-vegetated and re-flooded. Growth of fresh bog vegetation is creating nanotope zones which would have been largely lost during the active gullying stage. Thus there is re-development of good T1 low ridge, T2 high ridge, T3 hummock, and even A3 pools. The old T4 erosion hags are now becoming increasingly paludified from below as the water table in the former gully rises with the accumulating active bog vegetation. Photos taken from the pool system at NB 486588, but similar scenes can be found within most of the Lewis peatlands erosion complexes.

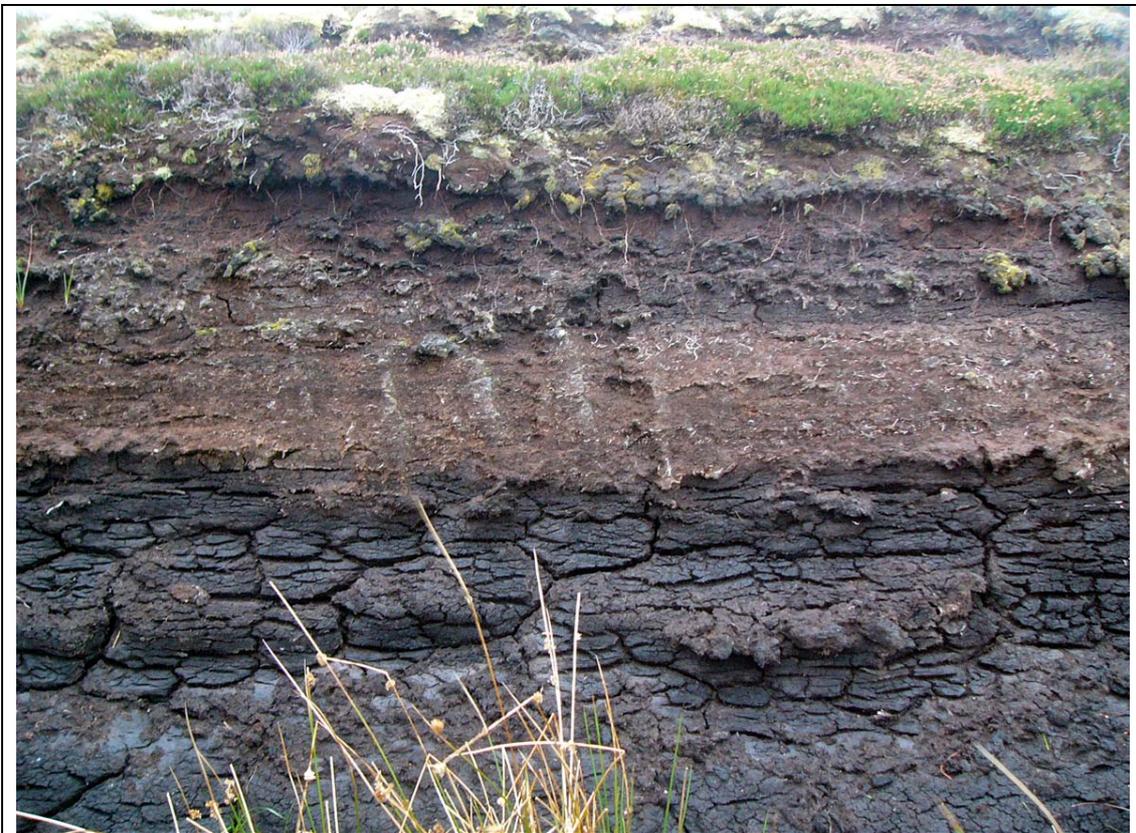
Figure 77. Illustration of layering typically found in the Lewis peat profile.
