**Article title:** FRP Seismic Strengthening of Concrete Structures

## FRP SEISMIC STRENGTHENING OF CONCRETE STRUCTURES

M. A. Ciupala\* and K. Pilakoutas\*\*

**Abstract:** This paper presents the experimental work carried out on a full scale concrete frame strengthened with Fibre Reinforced Polymer (FRP) composites. The frame was damaged, strengthened with FRP reinforcement and re-tested to assess the effectiveness of the strengthening technique. The natural frequencies of vibration, displacements, velocities and accelerations for both the unstrengthened and strengthened frame were recorded and compared.

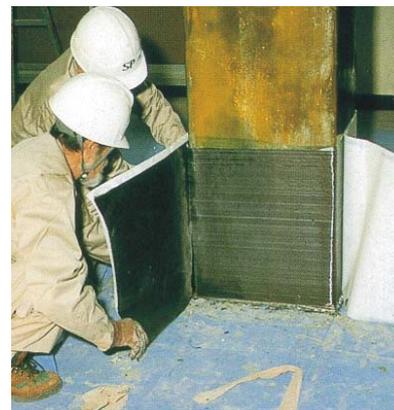
Fig. 1 FRP confinement of concrete columns

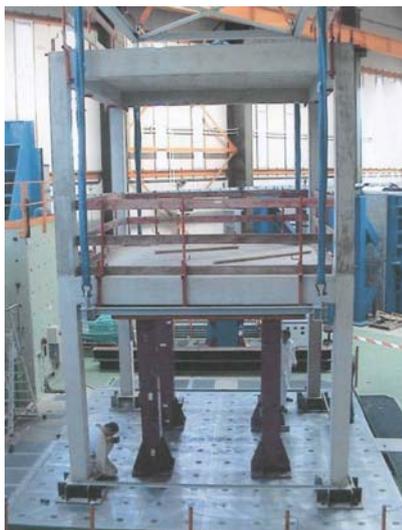
Initially, the bare frame (Fig. 2) was subjected to white-noise test, with frequencies varying between 0.5-50 Hz and a low acceleration level (max. 0.05g) in order to measure the natural frequencies of vibration.

The bare frame was afterwards damaged, being subjected to five uni-directional seismic tests with the maximum accelerations 0.05g, 0.10g, 0.2g, 0.3g and 0.4g. The natural frequencies of vibration of the frame were measured after each seismic test. The first two natural frequencies of vibration of the undamaged and damaged bare frame are presented in Table 1.

Fig. 2 Bare frame

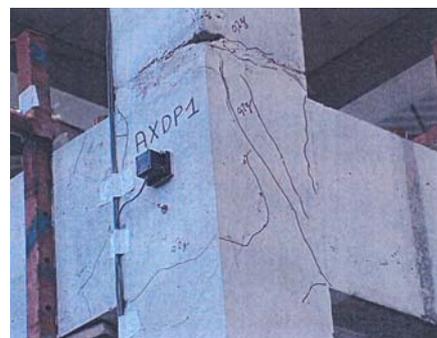
No damage was observed after the first two seismic tests. First damage occurred during the 0.2g seismic test. Diagonal cracks appeared at the joints of the 1<sup>st</sup> floor (Fig.3) and horizontal cracks formed under the joints of the 2<sup>nd</sup> floor. Some new horizontal cracks appeared above the joints of the 1<sup>st</sup> floor and in the columns during the 0.3g seismic test. During the last seismic test (0.4g), new cracks developed along the height of columns and spalling of concrete was noticed at the base of one column.

Fig. 3 Joint damage

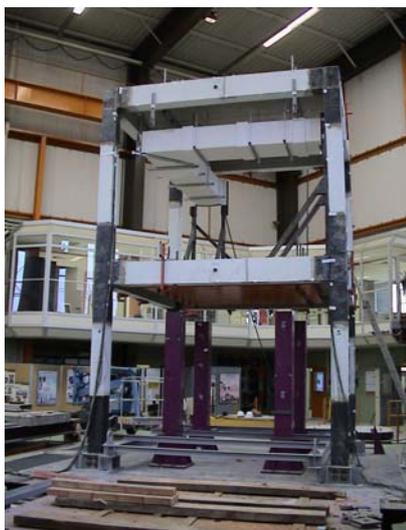
Since the most damaged areas were the joints and the end of the columns, the FRP confinement was applied at these locations (Fig.4). Very little amount of FRP reinforcement was applied at the end of the beams since the aim of the strengthening was to transfer the plastic hinges (zones with concentrated damage) from columns onto beams. In the columns and beams, the FRP material was applied with the fibers in the warp direction parallel to the axis of the members, while at the joints, the FRP confinement was applied at 45<sup>0</sup> to follow the shear (diagonal) cracks.

Fig. 4 FRP strengthened frame

The damaged frame was strengthened with CFRP unidirectional fabric (TFC<sup>®</sup>). The fabric is composed of 70% fibers in the warp direction and 30% in the weft direction, having the following characteristics: Young's Modulus 105 GPa, yield stress in tension 1700 MPa, thickness 0.48 mm.

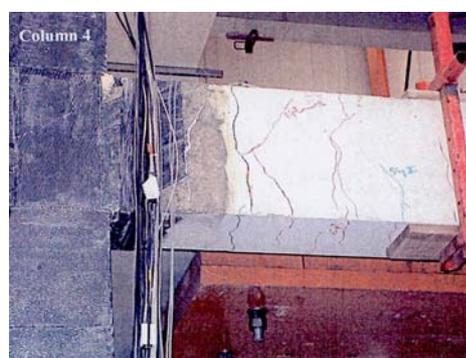
in beams (Fig.5) and columns after the 0.50g seismic test. Debonding and tearing of the FRP reinforcement was noticed at joints (Fig.6).

Fig. 5 Crack development in beams

At the end of the seismic test corresponding to 0.5g level of excitation, significant damage in the beams of the strengthened frame was noticed compared to the damage in columns. This shows that a transfer of plastic hinges from columns into beams might take place.
